# Tomco Techtips

ISSUE 9

## Two Exhaust Gas Recirculation (EGR) Valve Cases Solved

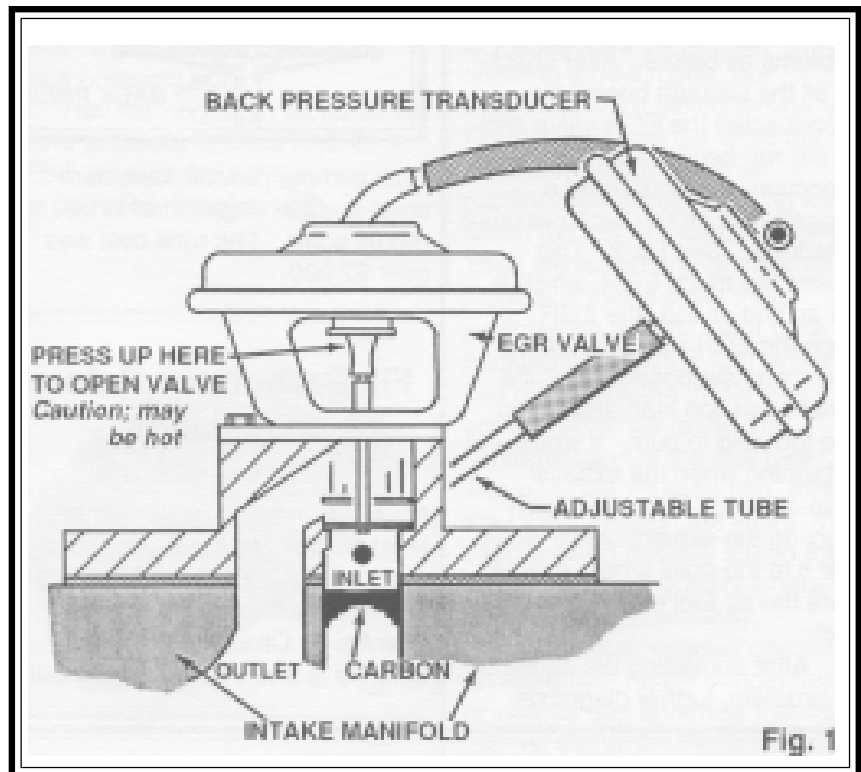
A number of checks were made. A new EGR valve did not correct the detonation. Further examination indicated a plugged passage for the exhaust gas through the intake manifold. It was clogged with an accumulation of carbon. This would not let the valve open and close as it should. The exhaust gases could not circulate, since there was no back pressure to actuate the back pressure transducer. See Fig. 1. Such a condition, if not corrected, can cause serious engine damage.

This condition is likely to happen on high mileage engines which use oil. The problem was further aggravated by carbon buildup in the combustion chamber, which decreased the size of the chamber and increased the compression ratio. The plugged passage has also been found on GM 2.5L, Ford V8 and other engines.

The solution is to clean the passage by scraping out the accumulation of carbon. Use caution to keep the carbon from falling into the manifold and be careful not to damage gasket surfaces.

A quick check to determine if this passage is open can be made as follows: With the engine idling, push the EGR valve diaphragm open (using a screwdriver if the engine is hot). See Fig. 1

A noticeable change in idle speed or engine stalling is an indication the EGR passage is open.

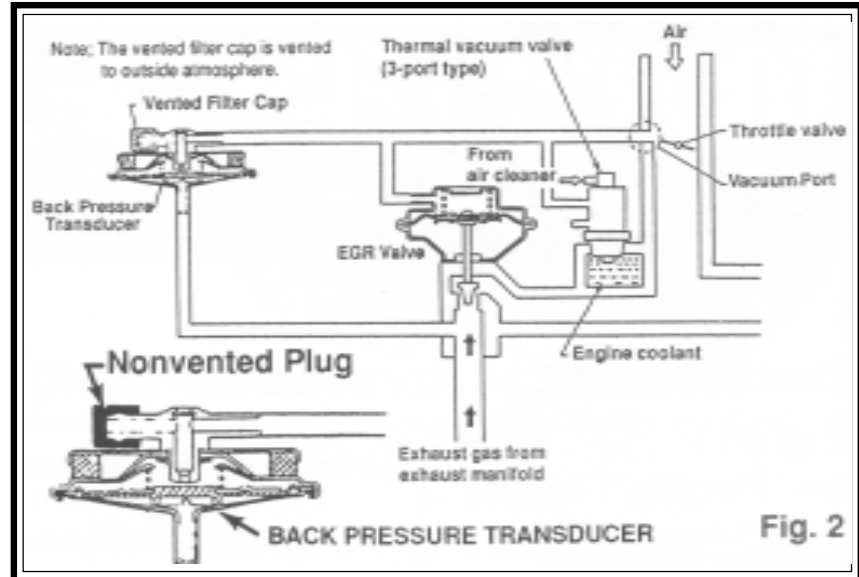
About \$800 worth of parts were used. Eventually serious engine damage occurred. Our inspection revealed over 60% cylinder leakage in cylinders 2 and 3.

Upon disassembly by a speciality repair shop, the following was discovered. Some of the valves were burned and the ring lands were broken on some of the pistons. When the car returned from the shop, it experienced some of the same driveability problems as before. After checking all the vacuum hoses, we disconnected the EGR valve and the car ran better. Upon further inspection, we discovered a plugged vent on the back pressure transducer. See fig. 2. This caused too much EGR, which is just as bad as too little EGR. Since the EGR was open more than it was supposed to be, the mixture was too lean and would take too long to burn. It would still be burning when the exhaust valve opened. This blow torch effect on the exhaust valve would heat it to the point where it would ignite the air fuel mixture prematurely.

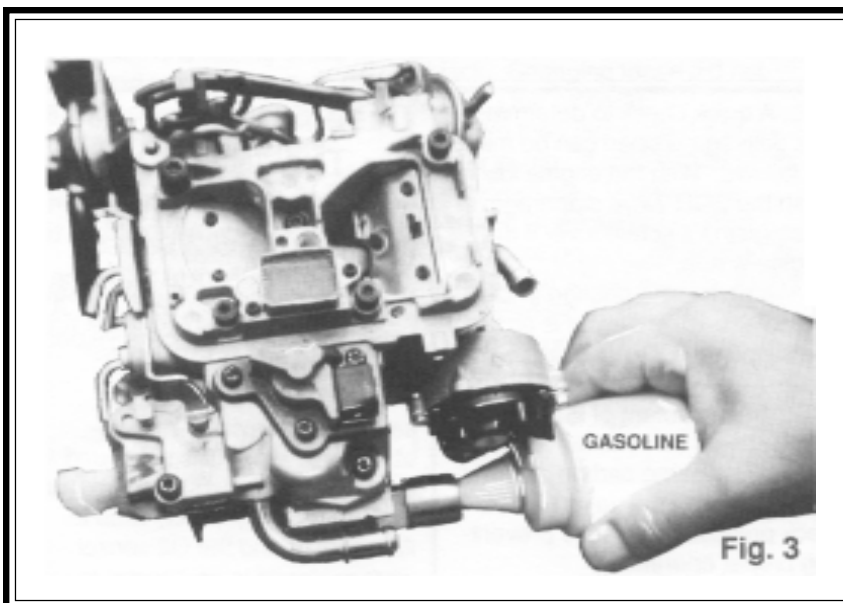
A dry carburetor should never be installed on an engine. Most of the carburetor service manuals advise you to fill the bowl before installing on the engine. See fig. 3. One of the main benefits is that you can check out the float and

During normal operation of the engine, a relatively small amount of fuel flows. When a dry carburetor is being primed, the high volume rush of fuel can pick up this foreign material and dump it into the empty carburetor bowl.

These deposits can clog the small internal passages in the carburetor. If the dirt particles stop between the inlet valve and its seat, flooding or a hard starting rich condition will result.

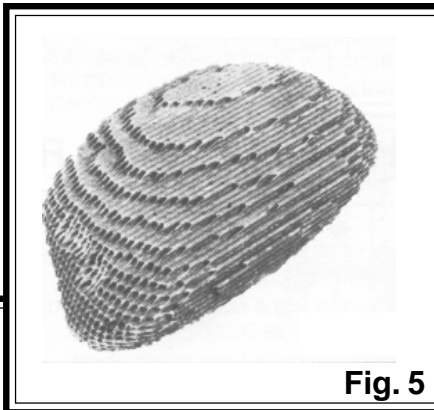
**Fig. 5**

The car was brought into our shop and the back pressure on the exhaust system checked. The back pressure was almost 15 P.S.I., which is far too high. The catalytic converter was removed and sectionalized. *See Fig. 4.* A third of the substrate in the front had eroded away. This was due to the high temperatures from the rich mixtures. There was a "chunk" left (about the size of a goose egg) that rolled around in the rear of the catalyst and intermittently plugged the opening which caused the high back pressure. *See fig 5.*

**Upper left:** a chunk about the size of a goose egg rolled around in the back of the catalyst.

When a new converter was installed along with the replaced air flow sensor, the problem was solved. A failed mass air flow

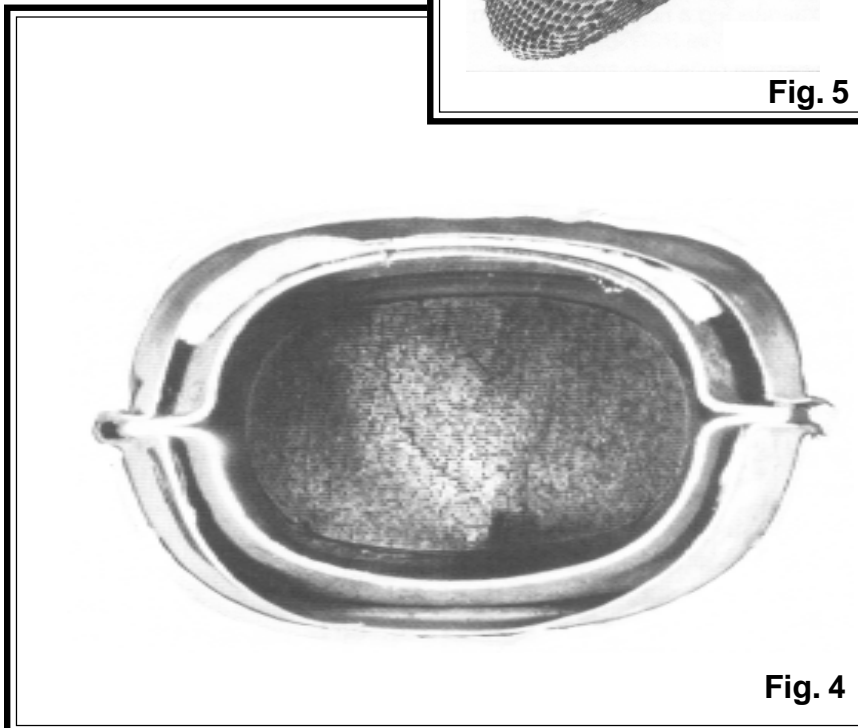
**Fig. 4**

**Left:** a third of the substrate in the front of the converter had eroded away.

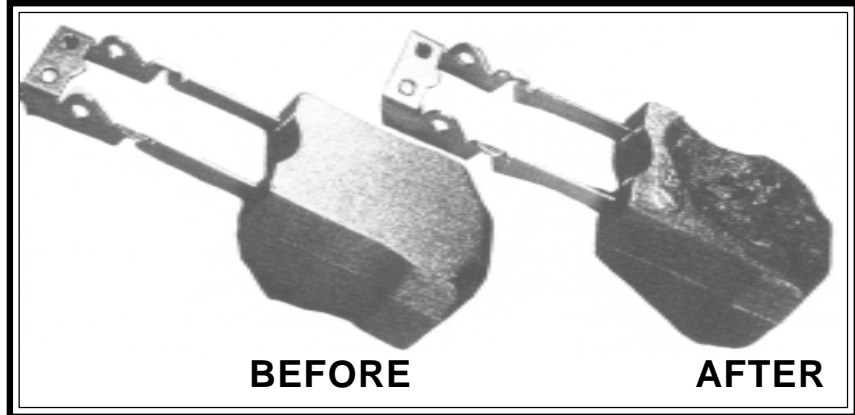
**Above:** An example of a normal nitrofil float (left) and a float damaged by backfiring (right).

Examination indicated these floats were partially burned by a backfire condition in the carburetor bores. This condition causes flame propagation into the carburetor bowl through bowl vents.

Replacing the float is

necessary, but will not correct this condition. Crossfire in the ignition system, extremely lean fuel mixture or a defect in the intake valve system should be suspect when this condition is experienced.
