# Tomco Techtips

ISSUE 10

## Stalling - Stumbling Engine

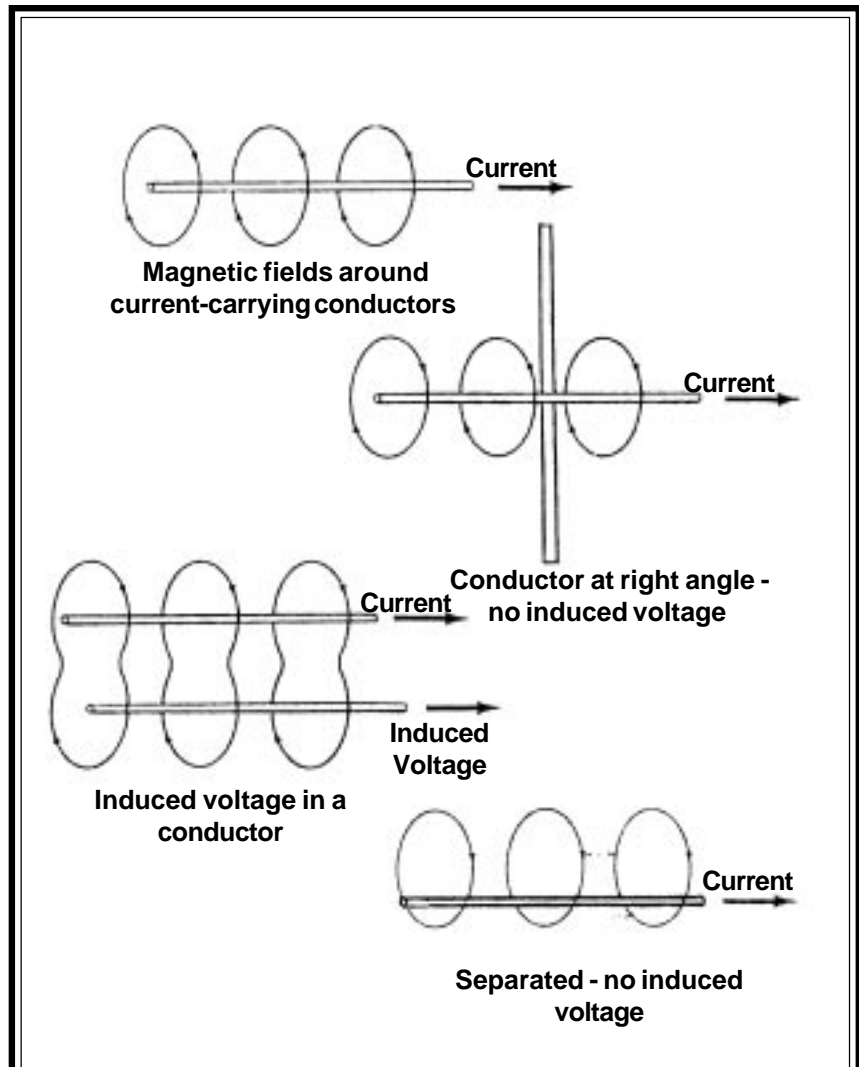
All vehicles with computer engine control systems can have various engine problems caused by a computer wiring harness being too close to starter, ignition or other engine wires. The harness should be five inches or more from all such high current or high voltage conductors. If the harness must cross a conductor, it should be at right angles.

This condition that causes this to occur is called "Faraday's Law of Induction" which states: "A magnetic force field that changes in time will develop a voltage in any conductor placed in the field, so that it cuts magnetic lines, a voltage will be induced across the conductor." This induced voltage occurs when the wires are parallel to each other because the conductor is cutting the magnetic lines of force. When the conductor is at right angles the magnetic lines are not being cut and no voltage is induced.

*Above: Figures describing "Faraday's Law of Induction" and how it applies to automobiles.*

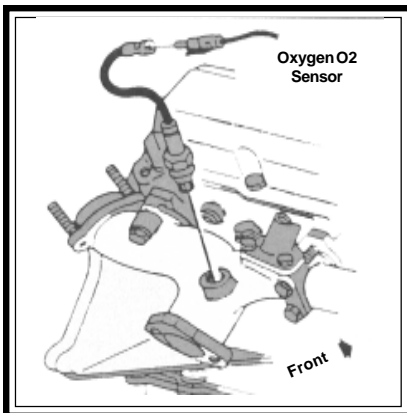
A hard to remove oxygen sensor may come out easier with rust penetrating oil, WD 40 and the like. Tests show that many penetrants not only loosen oxygen sensors, but also poison them.

Oxygen sensors are sensitive to "poisoning" if liquid of any type (that leaves a residue) penetrates the inner platinized surface of the zirconia cell (the heart of the zirconia type assembly).

Many oils and penetrates will burn off the outside of the zirconia cell when subjected to the high temperatures in the exhaust system. Replacement or voltage output testing with a digital voltmeter are the good answers.

A nonoperational oxygen sensor can cause expensive replacement and repairs - such as towing bills, burned up catalytic converters and excessive gasoline consumption.
