# Tomco Techtips

ISSUE 7

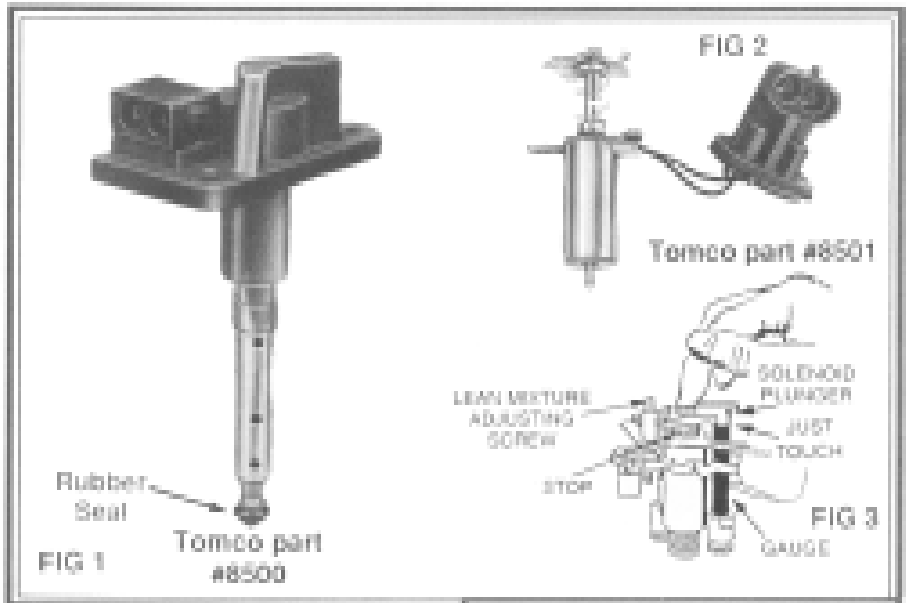
The small donut shaped rubber seal used on the 2SE mixture control solenoid is easily damaged, so care is required to install the solenoid without damaging the seal. Use a few drops of oil on the seal so it slips into place. (Fig 1)

Rochester 2ME dual and 4ME quadrajet carburetors are computer controlled by this type of solenoid. (Fig 2)

To avoid unnecessary re-adjustment, count the number of turns to bottom the lean stop screw before removing. It can then be put back in the same position when the new solenoid is installed. (Fig 3)

TOMCO part #8501 fits all computer controlled 2ME and 4ME model carburetors used on Chrysler 8 cyl. and GM 6 and 8 cyl. models from 1981 through 1990.

Both style solenoids should be checked on performance and mileage complaints and at every tune-up or 25 to 30,000 miles.

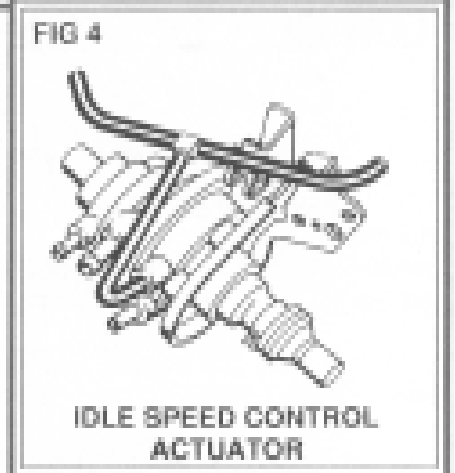
Late model Nissan Sentra's (1987-84) with Hitachi carburetors may develop an extremely high idle condition. This may be caused by a collapsed hose on the Idle Speed Control. (Fig 4)

These cars use a large vacuum actuated Idle Speed Control unit to adjust idle speed for varying load conditions. As the vacuum hoses leading to the speed control deteriorate with age, they tend to collapse and the vacuum won't bleed off. This causes the car to remain at higher than normal idle speeds.

To check for this condition, pull the vacuum hoses off the speed control, one at a time, to see if the idle speed is affected. Be sure that all the accessories, like the air conditioning, are off before making this test.

If this cures the high idle problem, replace the vacuum hoses and follow the factory recommended procedure for resetting the speed control.

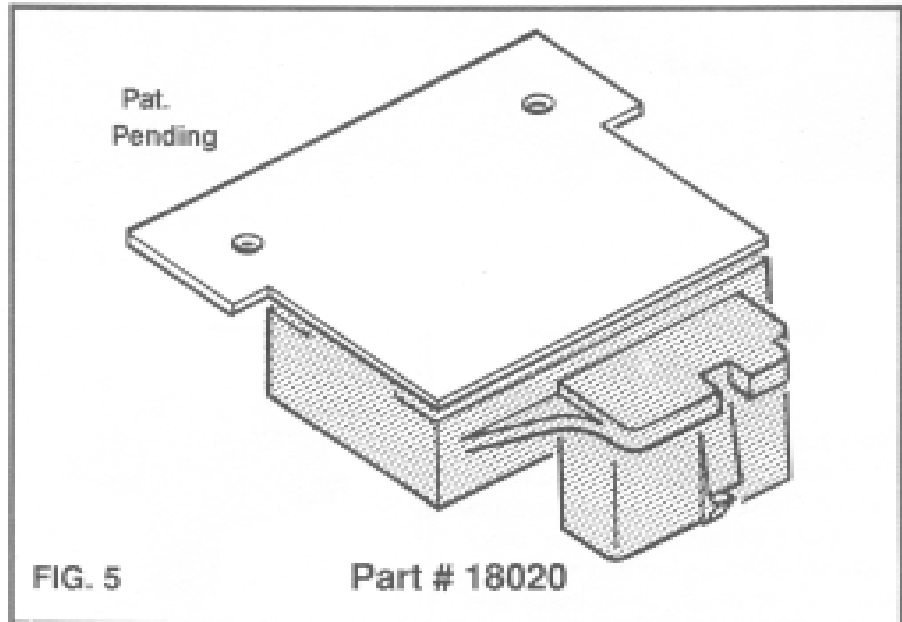
Tomco's Engine Performance Control Catalog (form C11-90) now lists MAP Sensor #18000 for 1986-81 Chrysler products. Requests have been received for a MAP Sensor covering 1987 and later models. In 1987, Chrysler changed the physical size and mounting hole locations of their OE type MAP Sensors. A Tomco sensor was not cataloged since nothing was available that would bolt right on. The vacuum-electrical characteristics and electrical connection remained the same as the earlier models. We have reason to believe the OE type used in later years has a high failure rate.

Failure of the original equipment type MAP Sensor sometimes involved melting of a plastic "potting" material that can clog the sensor's vacuum hose.

Tomco's MAP Sensor #18020, as shown in Fig 5, is the replacement on the 1990 - 87, 2.2 and 2.5L models (except turbo). Tomco's design is an improvement over the high failure rate original design.

Always check for blockage, cracks, leakage or collapsing of any vacuum operated device on today's vehicles.

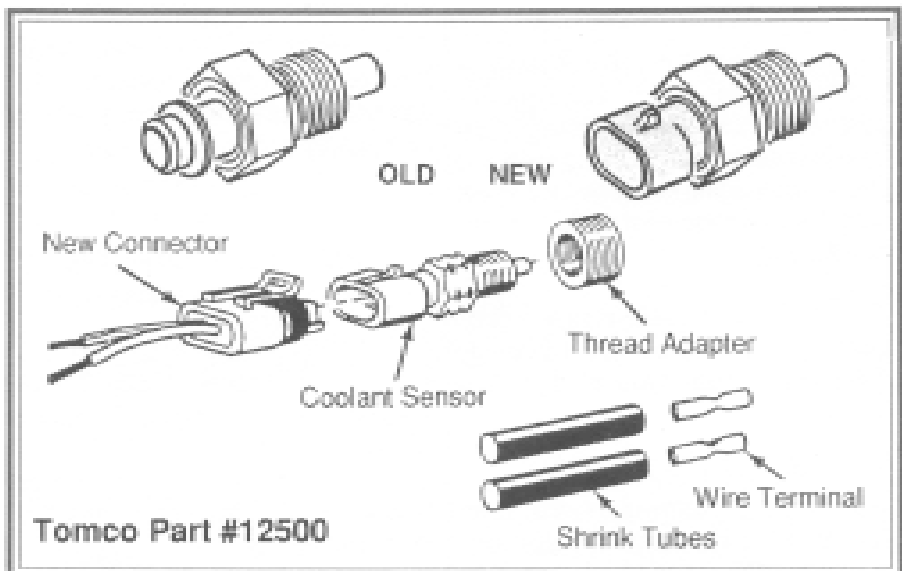
This early design ECT used a connector subject to corrosion that created resistance and a false signal to the computer (ECM). In some cases it was caused by leakage of antifreeze into the connector.

Several GM divisions issued a bulletin to their dealers announcing that this early sensor was to be replaced by a new style ECT with an oval connector. This change incorporated a connector kit.

Tomco part #12500 contains the new style ECT, connector, wire terminals and heatshrink tubes needed to make this update. A thread adaptor bushing is included so part #12500 will cover several of the early sensors with different thread sizes.

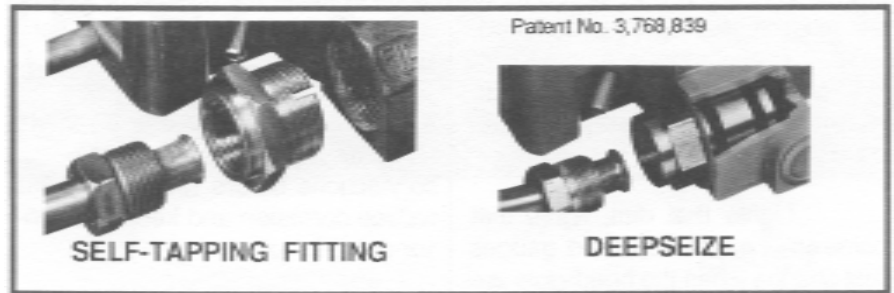
It's easy to strip the threads on the fuel inlet nut when changing the fuel filter on Rochester Q Jet or Dual Jet carburetors. We know of several cases where these threads went bad on carburetors that have never been serviced. Vibration of the long fuel line has been suspected of causing this damage.

The self-tapping repair fittings restore and deepen these threads. If the damage is too great, the "O" Ring type "Deepseize" Fitting will fix the leak. As the cost of new and rebuilt carburetors has increased, the use of these fittings can save the car owner over \$800 in some cases.

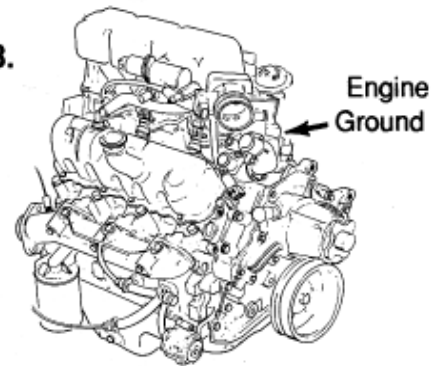
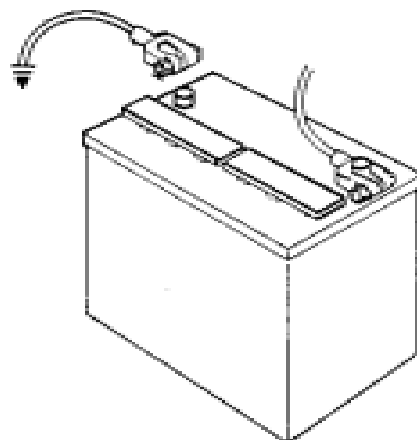
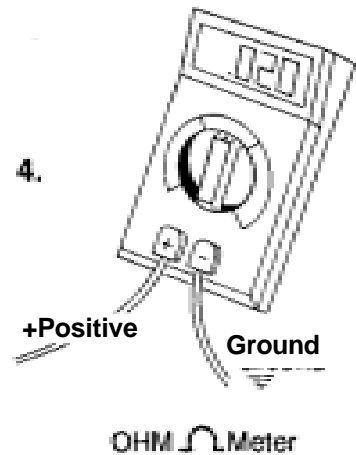
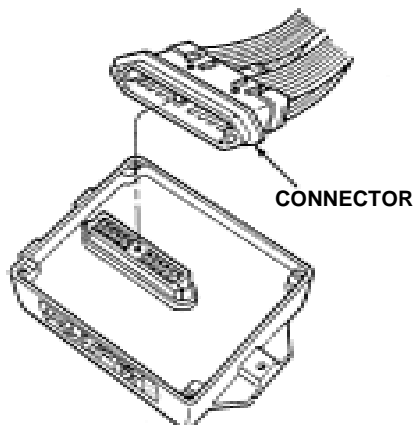
We recently encountered a late model Chrysler product that originally checked out to have a bad Oxygen O2 Sensor.

When a new sensor didn't fix the problem, we checked further with a digital type ohm meter between the computer sensor ground terminals and engine ground. (Find these terminals by checking a wiring diagram.)

with very little current flow. Any resistance in either the ground or sensor output circuit can make a good sensor act like a bad one.

Cleaning the engine to chassis and battery to engine ground so we had a maximum of .02 ohm resistance made the new sensor work as a new one should.

Conductive grease, available at radio supply stores, applied to connections before reassembly will reduce corrosion and keep the sensor doing its job.

1. Disconnect Battery

2. Check between the computer sensor ground terminals and engine ground. (Find these terminals by checking a wiring diagram.)
